Please find attached our Liner Damage Assessment, Repair and CQA Report for recent repairs on the MSW Cell E6 Sideslope Liner. Also attached is a figure showing the recommended MSW filling area in Cell E6.

Subject: Liner Damage Assessment, Repair, and Construction Quality Assurance Report
for Cell E6 Sideslope, Waimanalo Gulch Sanitary Landfill, Kapolei, HI

Figure 1
MSW Cell E6 Sideslope
Liner Damage Areas

Waste Management of Hawaii
Waimanalo Gulch Sanitary Landfill
Kapolei, Oahu, Hawaii

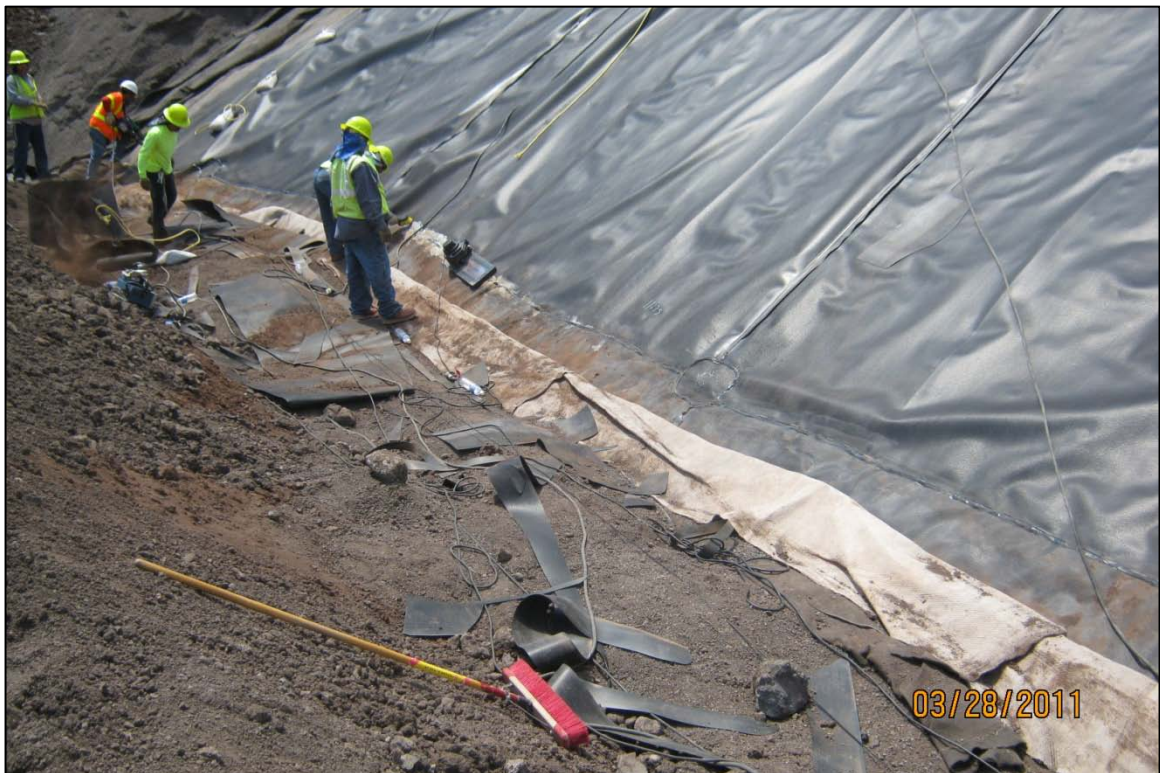
Photo 14: Vacuum box testing tie-in along the northern repair area.

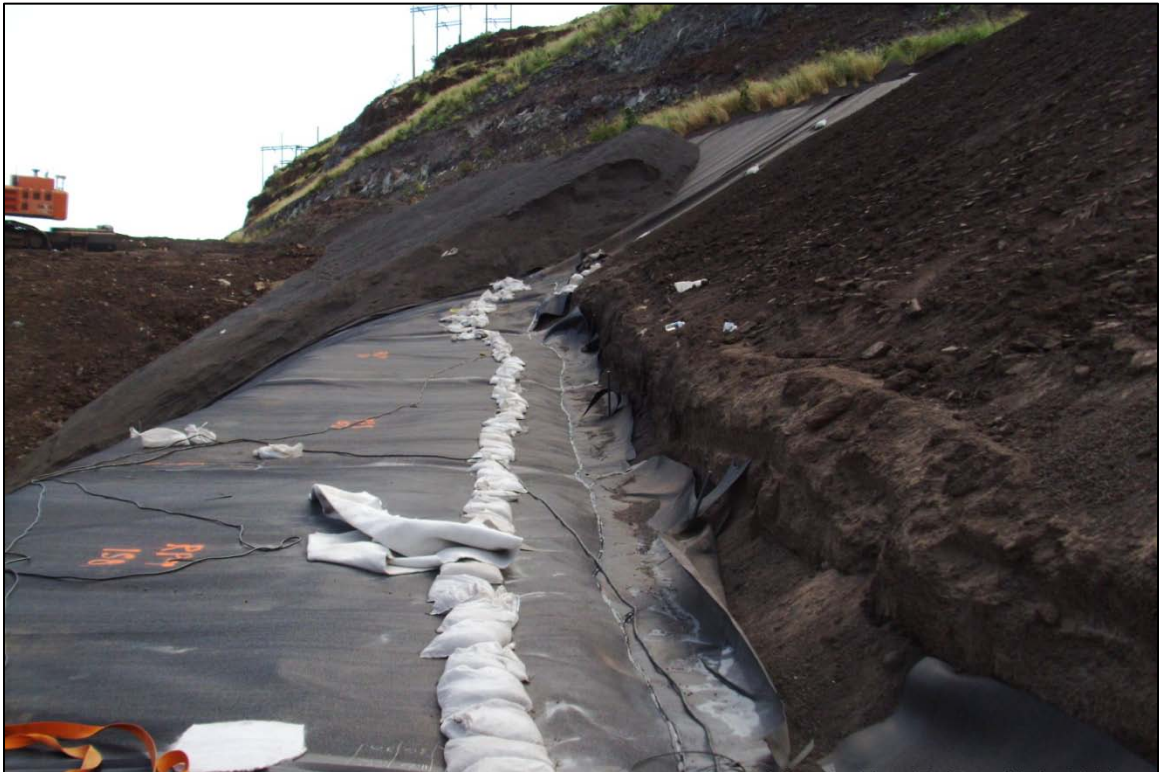
Photo 15: Encapsulated weld along the bench of the northern repair area, looking south.

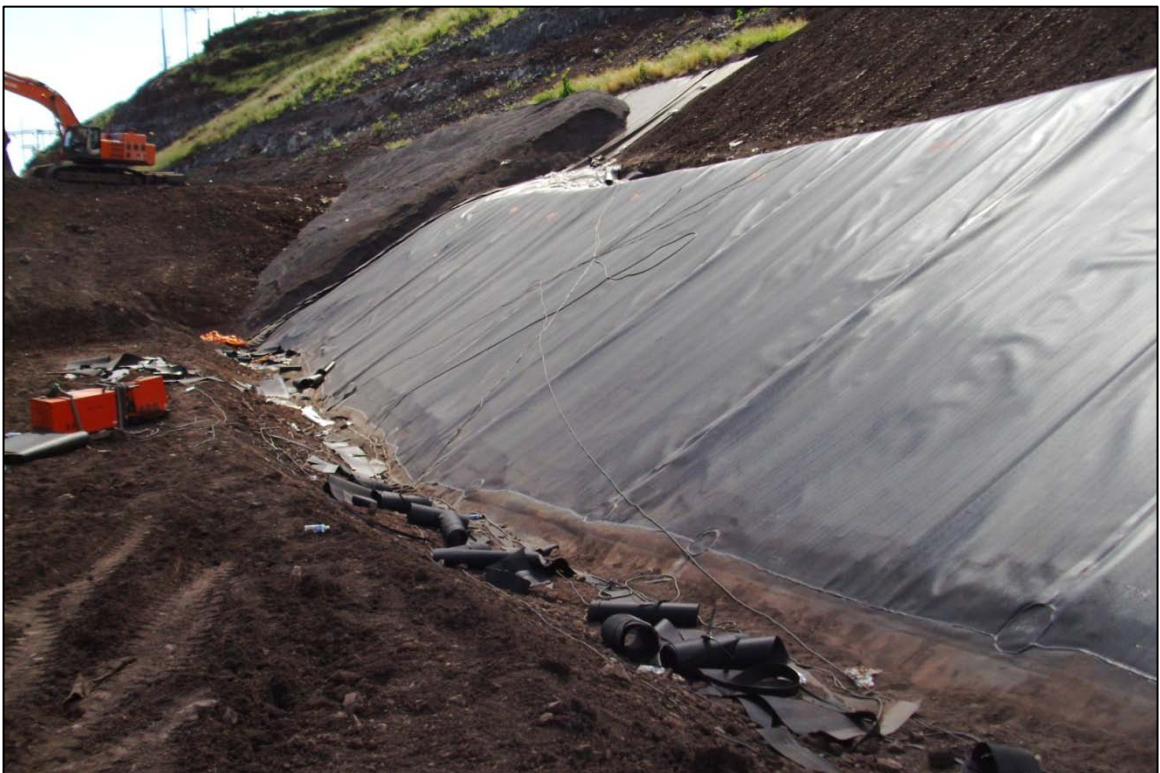
Photo 16: Tie-in to existing E6 liner system along the northern repair area, looking southwest..

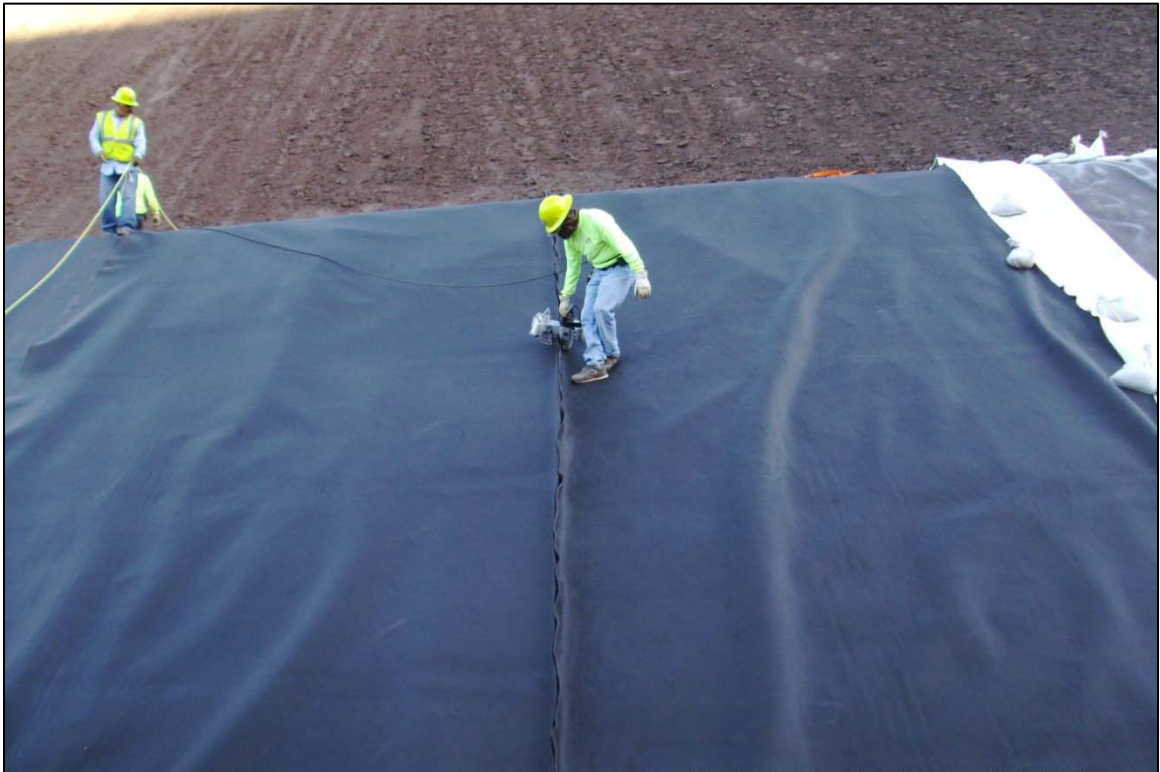
Photo 17: Sewing 16-oz geotextile on the northern repair area.

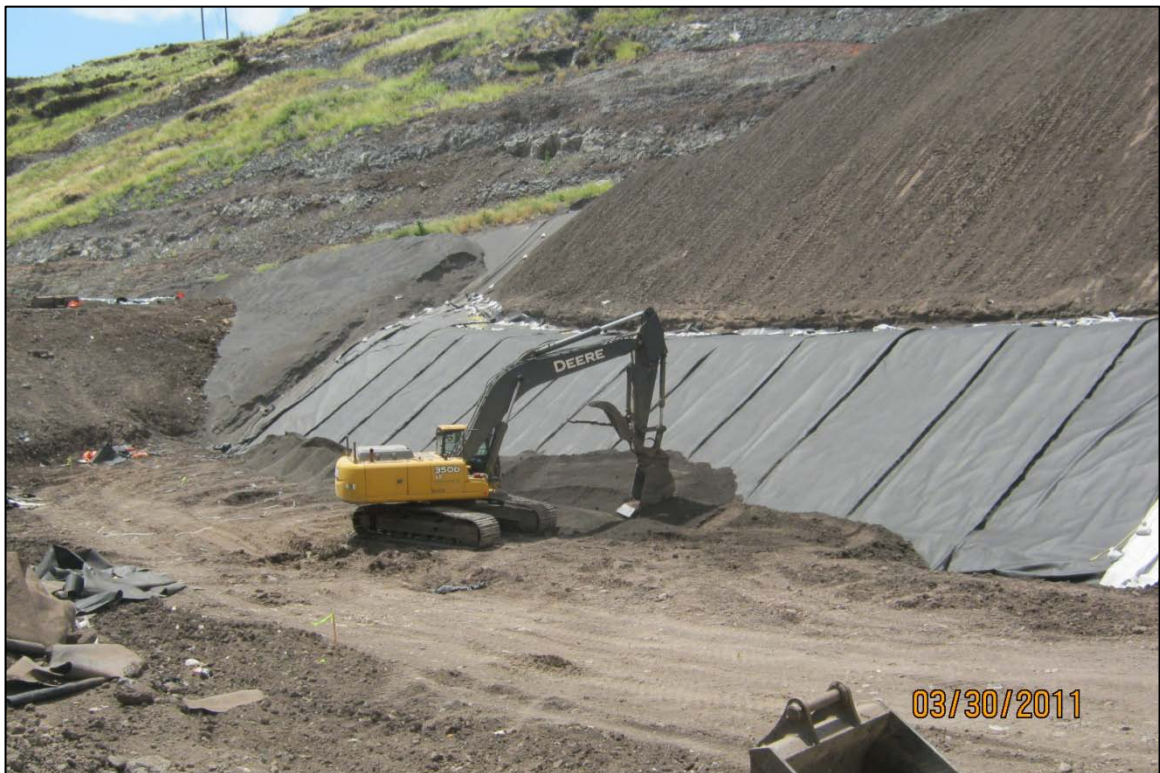
Photo 18: Placing operation layer over 16-oz geotextile at the northern repair area, looking southwest.
